# CITY OF SHELBY

## RAINBOW HOTEL PRELIMINARY ARCHITECTURAL REPORT AND BUSINESS PLAN

MAIN STREET - SHELBY, MONTANA  
NOVEMBER 03, 2014

# STRUCTURAL INSPECTION-1

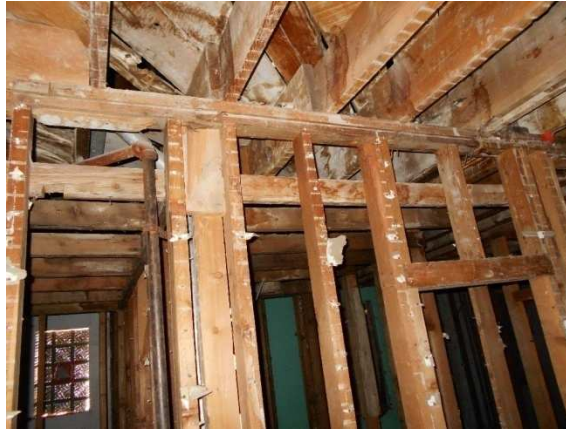
Photo 3: Second floor joists supported on interior corridor bearing wall.

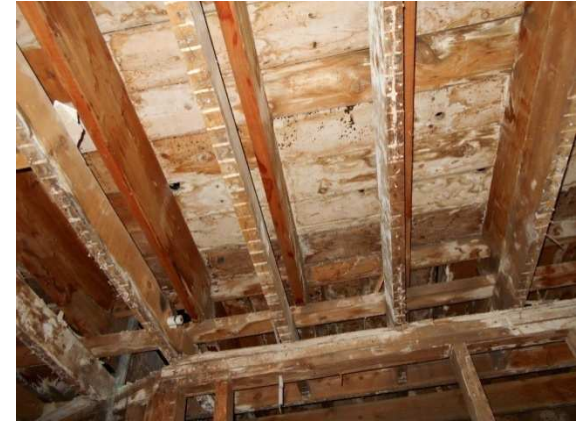
Photo 5: Third floor ceiling joists (below) supported on corridor bearing wall. The flat 2x member transfers load from the floor joists (above) to the ceiling joists.

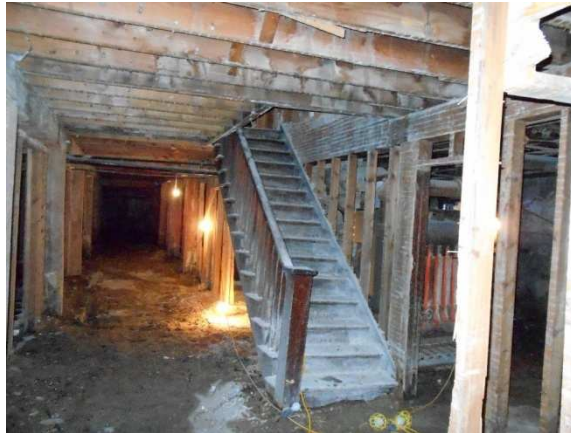
- The basement level exhibits the greatest amount of deterioration of the building. Two rows of 8x8 wood posts and 8x10 wood timber beams run north-south the length of the building, supporting the corridor bearing walls above (See Photo 9). The floor joists are supported by the beams on the interior, and are embedded in the exterior clay tile walls (See Photos 10 and 11). The joists, beams, and upper portions of the wood posts appear to be in good condition. However, the post bases and bottom portions of wood partition walls all have rot and/or are water damaged (See Photo 12).

Photo 9: Looking south down center corridor in basement. Rows of beams and columns on either side support interior bearing walls above.

- ☐ Remove the bottoms of the timber posts to sound-dry material, and place on elevated concrete pedestals to prevent future decay from contact with moisture.

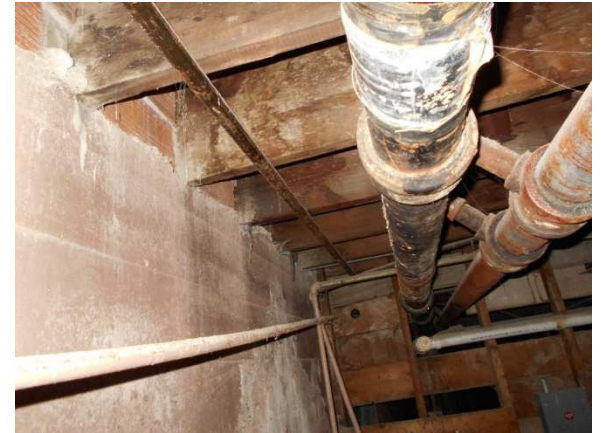
Photo 11: First floor joists embedded in exterior clay tile walls supported on concrete basement walls.

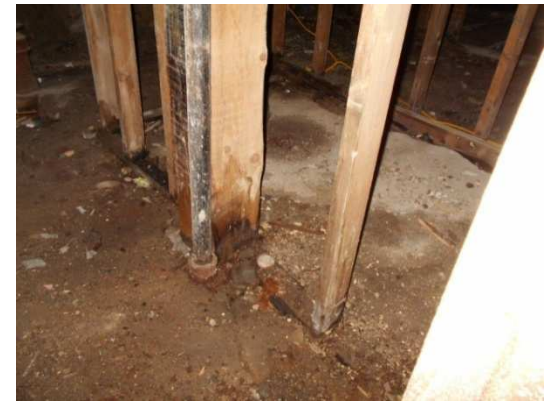
- The area requiring the most attention for long term use of the building is the basement. The soils in the basement were very moist with areas of standing water. The posts supporting the interior bearing lines have rotted at the base. The partition walls and floor joists also have significant rot and water damage.

Photo 12: Water damage and rot where columns and wood walls are in contact with dirt basement floor.

- ☐ Remove all water damaged partition walls and floor joists.
- ☐ The wood floor joists and bearing walls above are recommended to be left as close as possible to their current configuration.

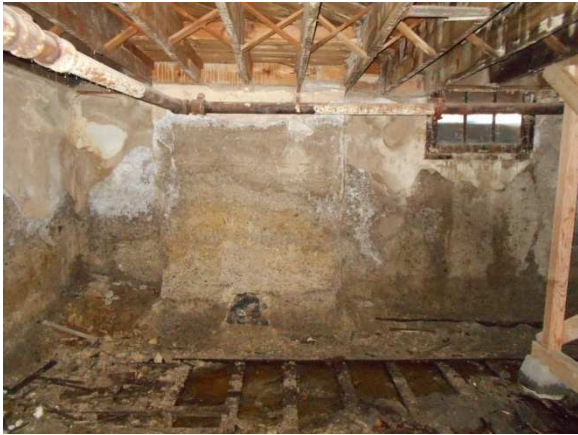
- The soils in the basement were very moist with standing water near the east wall and in the southwest corner. Floor joists had been supported directly on the earth, and are rotted and decaying (See Photos 13 and 14).

Photo 13: Southwest corner of basement has standing water and rotted earth supported floor joists. A temporary support is at the right of the photo.

- ☐ All gravity-Install a concrete floor slab with an under slab drainage system to a sump pump.
- ☐ Patch deteriorated concrete wall surfaces and seal any cracks.

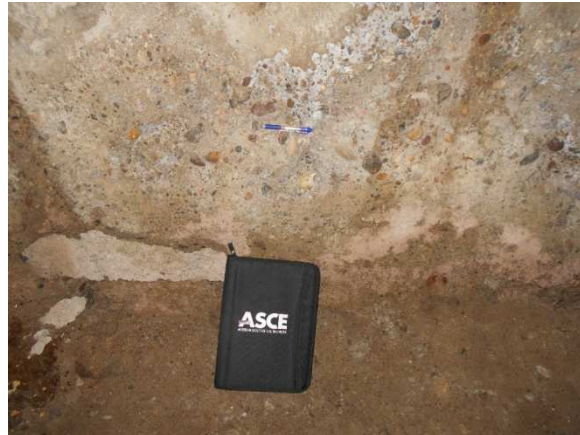
- For the most part, the basement walls are in fairly good condition with minimal cracking observed. Some of the interior concrete wall surfaces show signs of deterioration, especially noticeable in the mid-section of the west wall (See Photos 15 and 16). The damage appears to be caused by water and/or the damp conditions of the basement.

- Another likely cause of water in the basement is the combination of several at-grade basement window openings and the flat site drainage around the building. On the west wall, the gravel parking lot is flat, with a “swale” near the middle of the wall (See Photo 21). The interior surface of the concrete basement wall at this location shows obvious sign of water caused deterioration (See Photos 15 and 16).

Photo 15: West wall of basement shows deterioration on the inside surface, but minimal cracking.

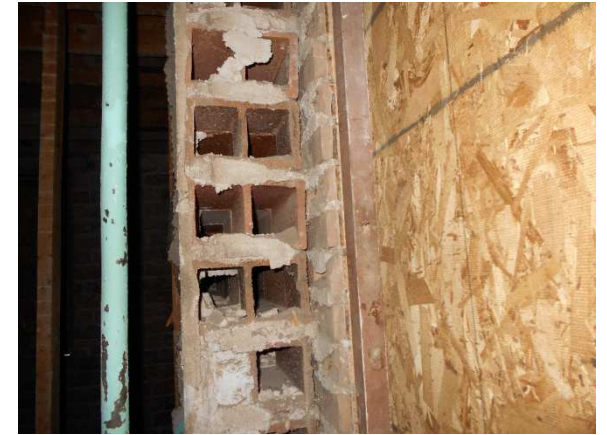
- The exterior walls of the building are in good condition. The clay tiles observed from the interior were sound with little cracking observed (See Photos 17 and 18). The exterior brick is also in good condition (See Photo 19). There is some minor cracking near the corners, and some deterioration of mortar due to water in various locations, including the lower brick courses (See Photo 20).

Photo 17: Exterior clay tile wall with brick veneer.

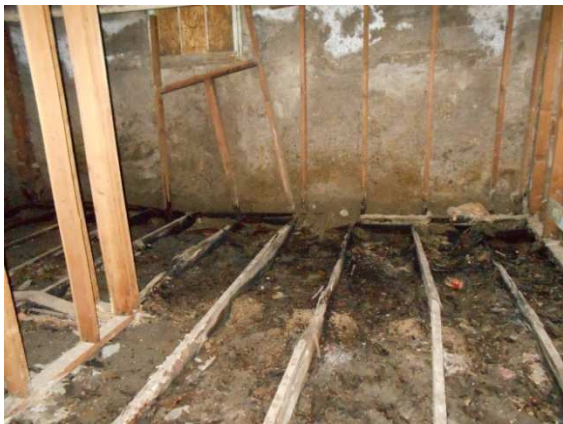
- The east wall has similar conditions with poor site drainage and at-grade window access points. The sidewalk actually slopes toward the foundation (see Photo 22). The soil was also very wet near the east wall in the basement at the time of the inspection (See Photo 14). The basement moisture and rot of wood members will need to be alleviated for continued use of the building.

Photo 14: East wall of basement with wet soils and rotted floor joists.

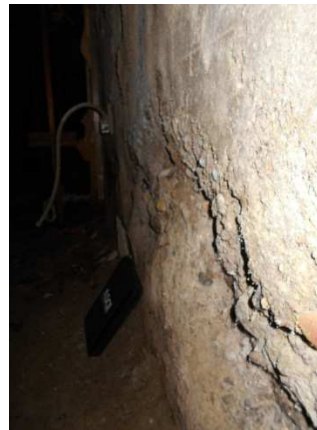
Photo 16: Looking south along deteriorated section of west basement wall.

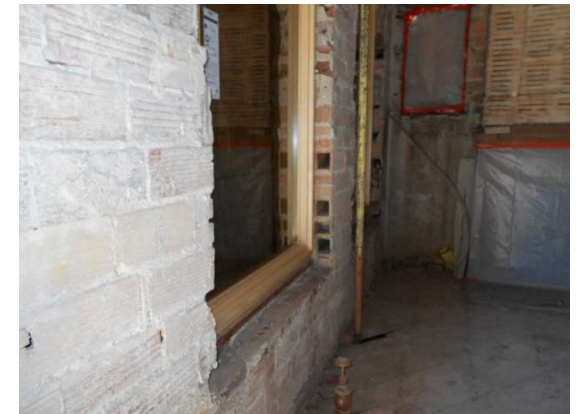
Photo 18: Clay tile south wall, looking west at fire place.

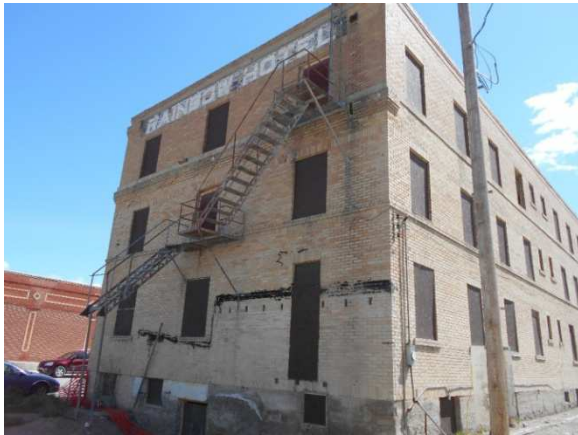
Photo 19: North and west walls. Brick veneer in good condition.

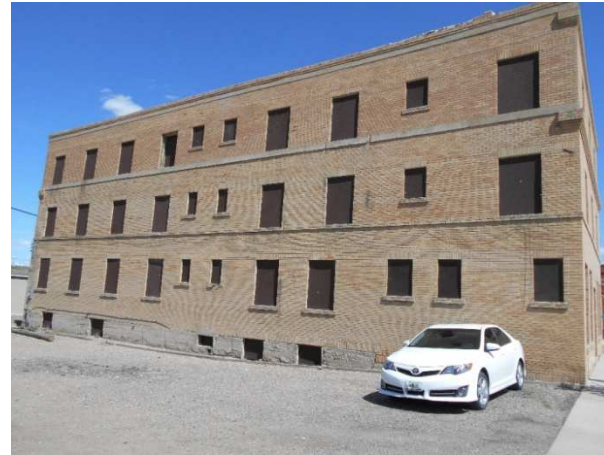
- The site grading around the perimeter of the building does not provide for positive drainage away from the building on both the east and west walls (See Photos 21 and 22). The lack of positive drainage combined with the proximity of window openings to grade are a likely cause for water infiltration into the basement.

Photo 21: West wall. Note at-grade basement windows and flat site grading.

- ☐ Eliminate excess moisture in the basement.
- ☐ Correct site grading to provide positive drainage away from all foundation walls.
- ☐ Seal at-grade window openings to prevent surface moisture infiltration.

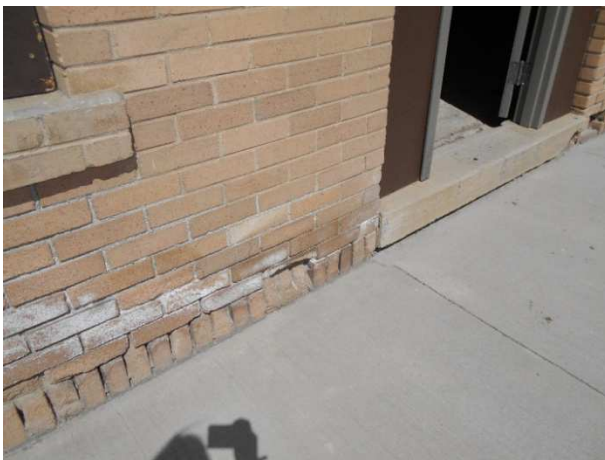
Photo 20: Some deterioration of bottom of south wall brick courses.

- ☐ Repair or replace clearly damaged framing members.
- ☐ On the exterior of the building, minor crack repair and repointing of the mortar on certain areas of the brick veneer will need to be done.

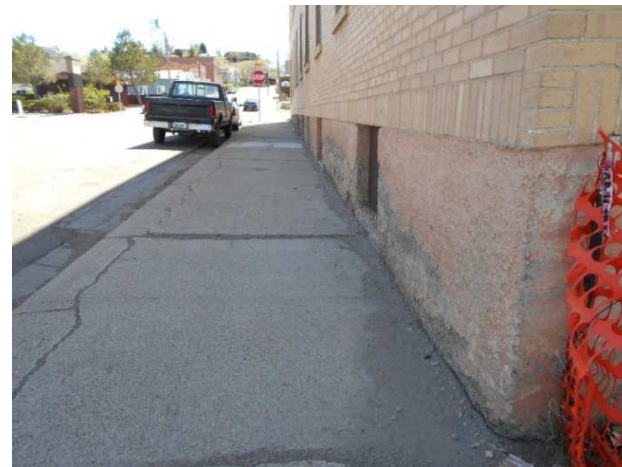
Photo 22: Sidewalk at east wall slopes toward the building.
