# CITY OF SHELBY

## RAINBOW HOTEL PRELIMINARY ARCHITECTURAL REPORT AND BUSINESS PLAN

MAIN STREET - SHELBY, MONTANA  
NOVEMBER 03, 2014

# STRUCTURAL INSPECTION-1

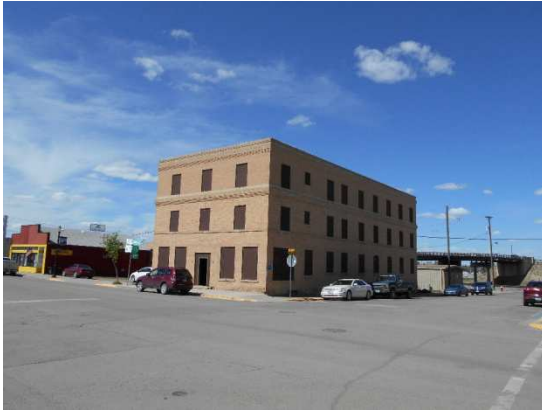
- The exterior walls of the building are in good condition. The clay tiles observed from the interior were sound with little cracking observed (See Photos 17 and 18). The exterior brick is also in good condition (See Photo 19). There is some minor cracking near the corners, and some deterioration of mortar due to water in various locations, including the lower brick courses (See Photo 20).

Photo 1: Exterior view of front (south and east) walls of the Rainbow Hotel.

- ☐ Repair or replace clearly damaged framing members.
- ☐ On the exterior of the building, minor crack repair and repointing of the mortar on certain areas of the brick veneer will need to be done.

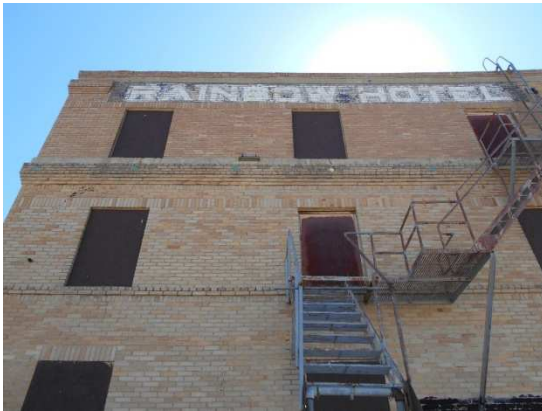
- The Rainbow Hotel Building was originally constructed as a two story building in about 1920. A third story was added to the structure in 1923. The three story building is constructed with wood framed floors, and full height clay brick exterior bearing walls (See Photo 1 and 2). The 1st floor is framed above a full basement. On the interior, full height wood stud bearing walls are located on each side of the main corridor down the center of the building. These walls are supported by beams and posts in the basement.

Photo 2: North wall of Hotel Building.

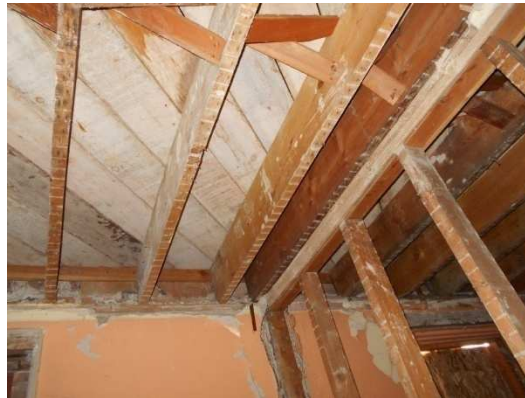
- At the time of inspection, environmental remediation had been done, and most interior finishes removed. The structural elements were open to view. The 1st and 2nd floor framing consists of diagonally sheathed 1x framing over 2x12 wood floor joists spaced at 16" o.c. The floor framing predominantly runs in the east-west direction and is supported on interior bearing walls (See Photo 3). At exterior walls most joists are "keyed in" to the clay tile wall while others appear to be supported on a wood ledge (See Photo 4). A small portion of framing spans in the north/south direction on the north end of the building.

Photo 4: Second floor joists supported at exterior clay tile wall.

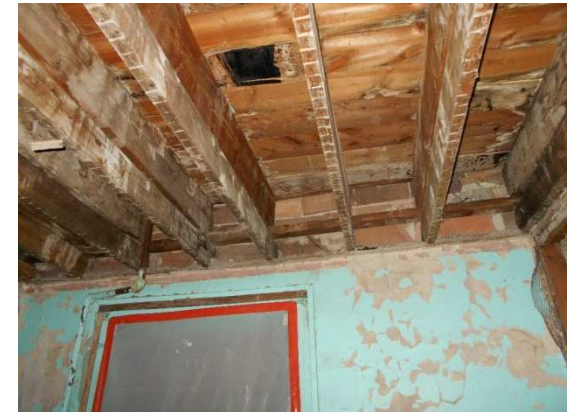
- The 3rd floor framing was originally a roof, and the framing is slightly different than the 1st and 2nd floors. The "floor deck" planking of the third floor is placed perpendicular to the floor joists rather than diagonally. Ceiling joists consisting of 2x6 joists are spaced at 16" o.c. and are supported directly on the interior bearing walls and are embedded in the exterior clay tile wall. A 2x bearing plate runs perpendicular to and on top of the ceiling joists and supports 2x10 floor joists above also spaced at 16" o.c. (See Photos 5 and 6).

Photo 6: Third floor ceiling and floor joists supported on exterior clay tile wall.

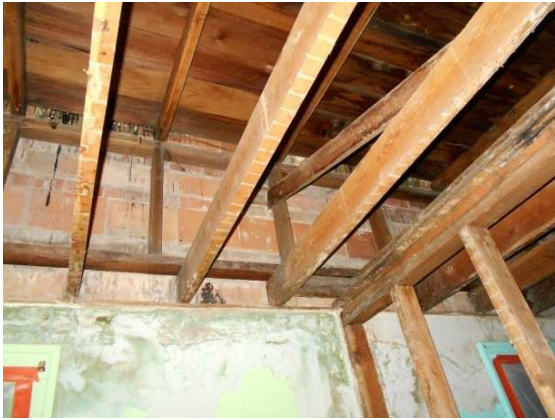
- The framing of the current roof is not as conventional as the floor framing, and appears to have slope built into the system for drainage. There is an interstitial space between ceiling joists and the higher roof joists. The 2x10 ceiling joists at 16" o.c. run east-west between interior corridor bearing walls and are embedded in the exterior clay tile wall (See Photo 7 and 8). The 2x6 roof joists above are spaced at 24" o.c. and supported on rows of cripple walls that run north-south that are supported by the ceiling joists. The cripple walls are spaced at about 8 to 9 feet on center.

Photo 7: Ceiling and roof joists at exterior wall.

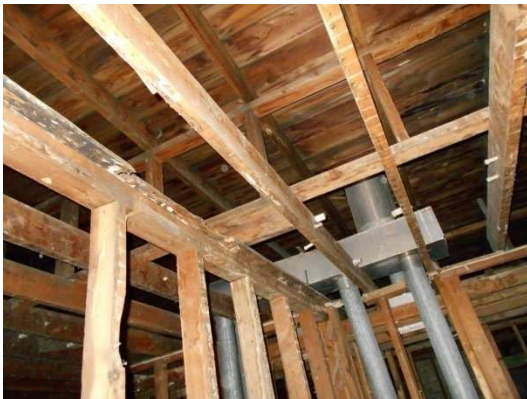
Photo 8: 2x6 roof joists are supported by 2x cripple walls which are carried by 2x10 ceiling joists.

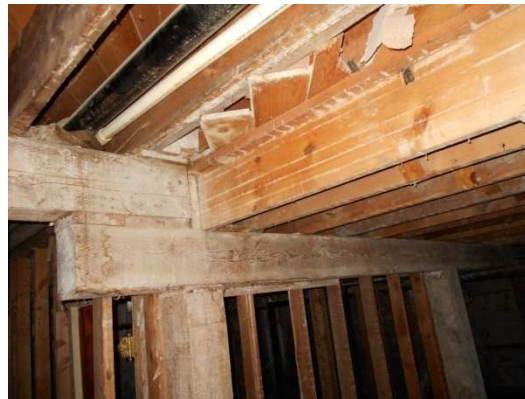
Photo 10: 2x12 floor joists supported on timber beams and columns in the basement. Floor elevation steps above.
